**Flood Control Project Maintenance
Levee Inspections**

Maintenance Issue Types Only, Levee Inspection Report By Mile - Spring 2018

Reclamation District No. 2060 Hastings

Waterway	Bank	Unit Miles	Inspection Start/End	Inspector
Unit No. 01 Lindsey Slough	Left	6.97	03/28/2018 03/28/2018	Keith Millard

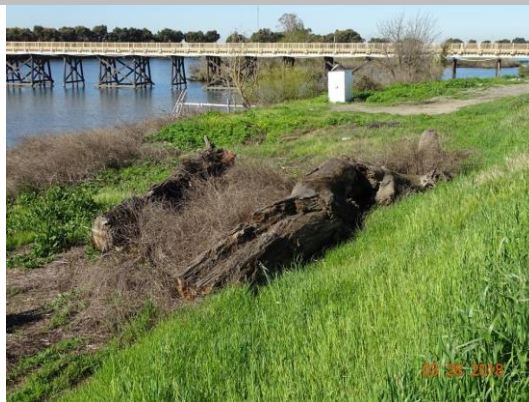
Photo 1 of 1 : SP_2018_RD2060_241_57_20180328_00146.jpg

LM Start	0.30	Rating **	M	Issue No.	57
LM End	0.30	Issue Type +	Ma	Location *	WS
Category	Earthen Levee		GPS Latitude/Longitude		
			Start	End	
Item	Encroachments		38.247623 °	38.247623 °	
			-121.701642 °	-121.701642 °	
DWR ID	DWR_RD2060_01_s_2018_57				
Comment Code					
TR : Tree or limb					
Inspector Comment					
Large tree trunk was hauled out of water in 2017. Should be removed from waterside berm.

Remove tree trunk from waterside slope.

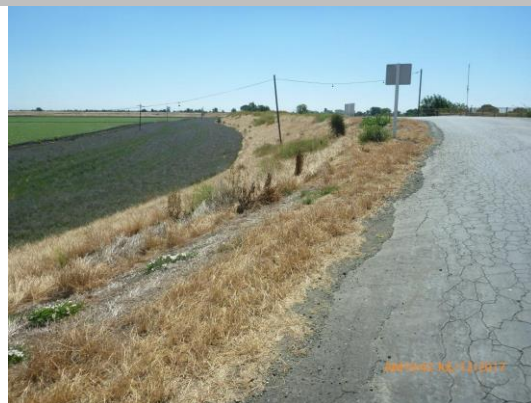
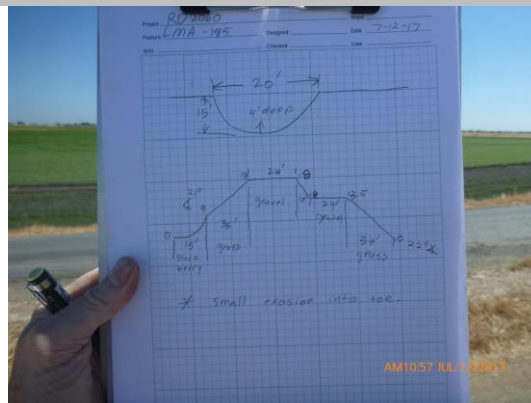
Photo 6 of 6 : SP_2018_RD2060_241_5_20180305_00006.jpg

LM Start	0.40	Rating **	M	Issue No.	5 (cont)					
LM End	0.40	Issue Type +	Ma	Location *						
Category	Supplemental		GPS Latitude/Longitude							
			Start	End						
Item	2017 Storm Damage		38.247894 °	38.247911 °						
			-121.703492 °	-121.703539 °						
DWR ID	DWR_RD2060_01_f_2017_5									
Comment Code										
Inspector Comment										
Levee Evaluation Comments Description: Erosion commences approximately 3/4 of the way down the slope, near the water line towards the waterside toe. Site ID No: 358 Site Designation: LMA-185 Repair Type: Erosion Rating: Area of Concern Field Date: 7/12/2017 Notes: Small erosion into bank.

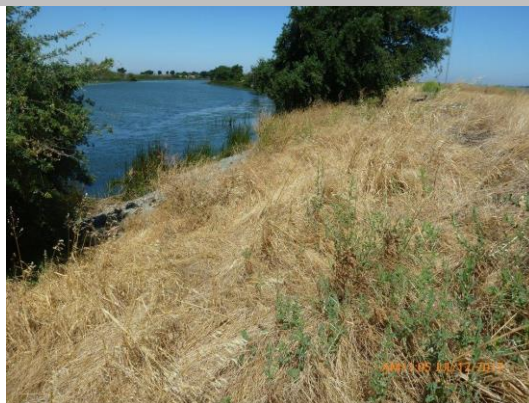
LM Start	0.41	Rating **	M	Issue No.	8 (cont)	
LM End	0.42	Issue Type +	Ma	Location *		
Category	Supplemental			GPS Latitude/Longitude		
				Start	End	
Item	2017 Storm Damage			38.248036 °	38.248017 °	
				-121.703539 °	-121.703789 °	
DWR ID	DWR_RD2060_01_f_2017_8					
Comment Code						
Inspector Comment						
Levee Evaluation Comments						
Description:Erosion commences approximately halfway down the water side slope extending in to existing rip rap. Existing rip rap appears to have been pulled off in this section.						
Site ID No:359						
Site Designation:LMA-186						
Repair Type: Erosion						
Rating:Area of Concern						
Field Date:7/12/2017						
Notes: Site had riprap but is eroded away. Minor erosion in toe of levee.

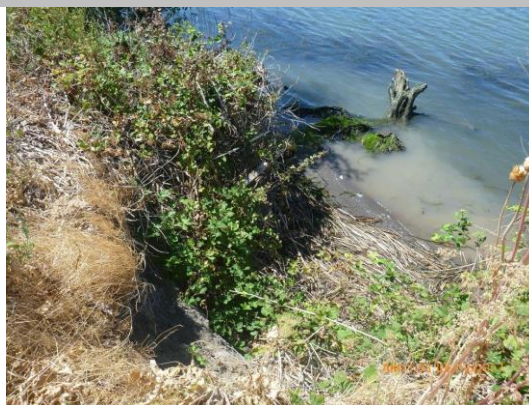
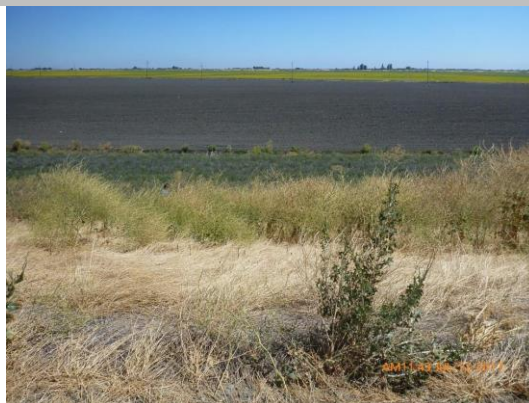
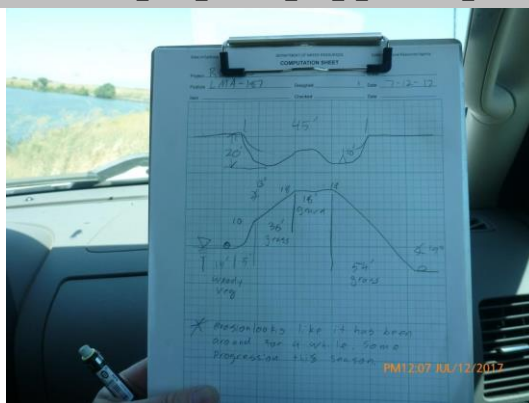
Photo 3 of 3 : SP_2018_RD2060_241_9_20180305_00012.jpg

LM Start	0.75	Rating **	M	Issue No.	9
LM End	0.76	Issue Type +	Ma	Location *	
Category	Supplemental			GPS Latitude/Longitude	
				Start	End
Item	2017 Storm Damage			38.249314 °	38.249400 °
				-121.709461 °	-121.709608 °
DWR ID	DWR_RD2060_01_f_2017_9				
Comment Code					
Inspector Comment					
Levee Evaluation Comments					
Description: Erosion commences approximately halfway down the water side slope extending in to existing rip rap. Erosion is concentrated near the waterline. Existing rip rap appears to have been pulled off in this section.					
Site ID No: 360					
Site Designation: LMA-187					
Repair Type: Erosion					
Rating: Area of Concern					
Field Date: 7/12/2017					
Notes: Erosion looks old but has progressed this year.

LM Start	0.75	Rating **	M	Issue No.	9 (cont)
LM End	0.76	Issue Type +	Ma	Location *	
Category	Supplemental		GPS Latitude/Longitude		
			Start	End	
Item	2017 Storm Damage		38.249314 °	38.249400 °	
			-121.709461 °	-121.709608 °	
DWR ID	DWR_RD2060_01_f_2017_9				
Comment Code					
Inspector Comment					
<p>Levee Evaluation Comments</p> <p>Description: Erosion commences approximately halfway down the water side slope extending in to existing rip rap. Erosion is concentrated near the waterline. Existing rip rap appears to have been pulled off in this section.</p> <p>Site ID No: 360</p> <p>Site Designation: LMA-187</p> <p>Repair Type: Erosion</p> <p>Rating: Area of Concern</p> <p>Field Date: 7/12/2017</p> <p>Notes: Erosion looks old but has progressed this year.</p>

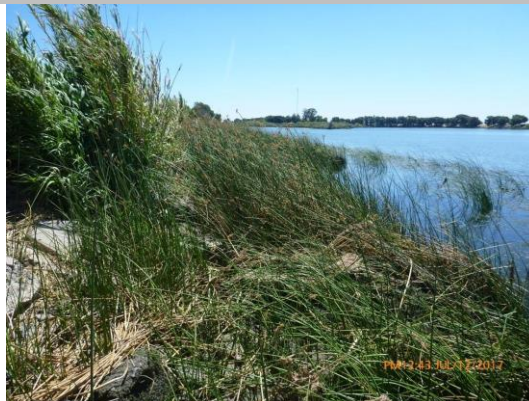
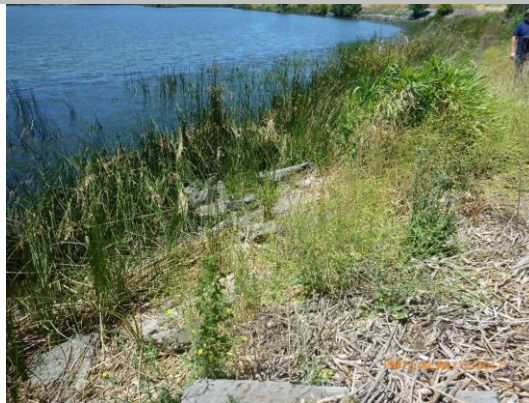
LM Start	0.92	Rating **	M	Issue No.	10
LM End	0.93	Issue Type +	Ma	Location *	
Category	Supplemental			GPS Latitude/Longitude	
				Start	End
Item	2017 Storm Damage			38.250875 °	38.250953 °
				-121.711942 °	-121.712078 °
DWR ID	DWR_RD2060_01_f_2017_10				
Comment Code					
Inspector Comment					
Levee Evaluation Comments Description:Sloughing commences approximately halfway down the water side slope. Site ID No:361 Site Designation:LMA-188 Repair Type: Erosion Rating:Area of Concern Field Date:7/12/2017 Notes: Minor sloughing, mostly riprap has moved down the slope and into channel.

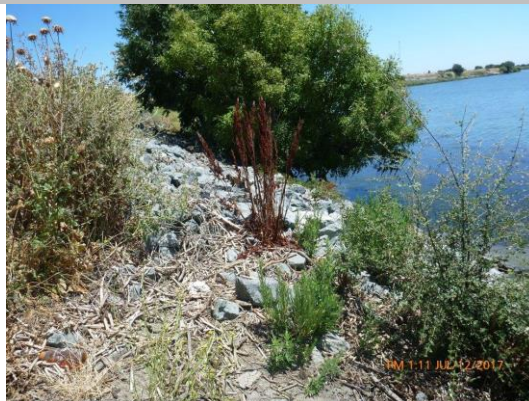
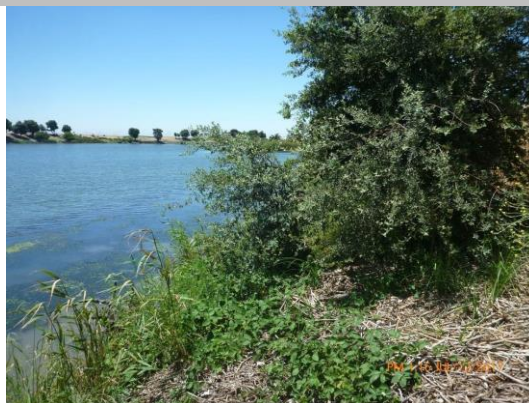
Photo 2 of 3 : SP_2018_RD2060_241_15_20180305_00018.jpg

LM Start	1.04	Rating **	M	Issue No.	15
LM End	1.08	Issue Type +	Ma	Location *	
Category	Supplemental			GPS Latitude/Longitude	
				Start	End
Item	2017 Storm Damage			38.251058 °	38.250872 °
				-121.714050 °	-121.714792 °
DWR ID	DWR_RD2060_01_f_2017_15				
Comment Code					
Inspector Comment					
Levee Evaluation Comments					
Description:Erosion commences approximately 3/4 of the way down the water side slope concentrated at the waterline.					
Site ID No:362					
Site Designation:LMA-189					
Repair Type: Erosion					
Rating:Area of Concern					
Field Date:7/12/2017					
Notes: Erosion due to lack of revetment. Erosion ends at riprap downstream. Vertical cut at summer wse.

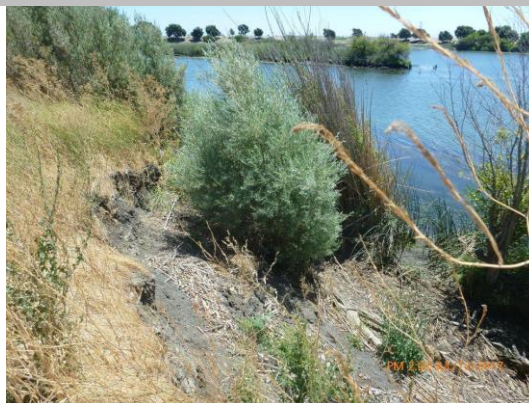
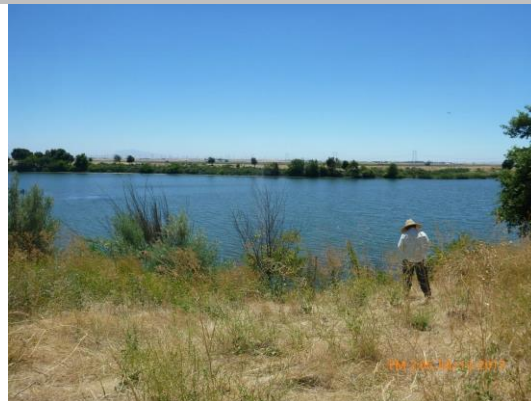
LM Start	1.22	Rating **	A/W	Issue No.	17	
LM End	1.23	Issue Type +	Ma	Location *		
Category	Supplemental			GPS Latitude/Longitude		
				Start	End	
Item	2017 Storm Damage			38.251186 °	38.251289 °	
				-121.717114 °	-121.717264 °	
DWR ID	DWR_RD2060_01_f_2017_17					
Comment Code						
Inspector Comment						
Levee Evaluation Comments						
Description:Erosion commences approximately 1/4 of the way down the water side slope extending to the toe.						
Site ID No:364						
Site Designation:LMA-191						
Repair Type: Erosion						
Rating:Critical						
Field Date:7/12/2017						
Notes: Very deep erosion that extends halfway into slope. Intact riprap on both sdes of erosion. Rated serious but could be critical if erosion cuts deep into prism.

LM Start	1.22	Rating **	A/W	Issue No.	17 (cont)	
LM End	1.23	Issue Type +	Ma	Location *		
Category	Supplemental			GPS Latitude/Longitude		
				Start	End	
Item	2017 Storm Damage			38.251186 °	38.251289 °	
				-121.717114 °	-121.717264 °	
DWR ID	DWR_RD2060_01_f_2017_17					
Comment Code						
Inspector Comment						
Levee Evaluation Comments						
Description:Erosion commences approximately 1/4 of the way down the water side slope extending to the toe.						
Site ID No:364						
Site Designation:LMA-191						
Repair Type: Erosion						
Rating:Critical						
Field Date:7/12/2017						
Notes: Very deep erosion that extends halfway into slope. Intact riprap on both sdes of erosion. Rated serious but could be critical if erosion cuts deep into prism.

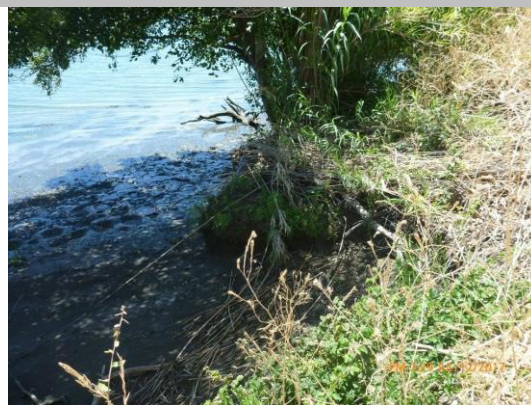
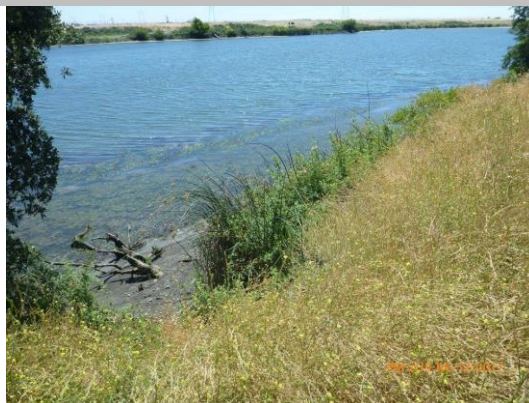
LM Start	1.39	Rating **	A/W	Issue No.	20
LM End	1.56	Issue Type +	Ma	Location *	
Category	Supplemental			GPS Latitude/Longitude	
				Start	End
Item	2017 Storm Damage			38.251886 °	38.252619 °
				-121.719933 °	-121.722842 °
DWR ID	DWR_RD2060_01_f_2017_20				
Comment Code					
Inspector Comment					
Levee Evaluation Comments					
Description:Erosion commences approximately halfway down the water side slope extending to the toe.					
Site ID No:365					
Site Designation:LMA-192					
Repair Type: Erosion					
Rating:Serious					
Field Date:7/12/2017					
Notes: Several deep narrow cuts into levee, but mostly minor erosion at highwater line.

LM Start	1.39	Rating **	A/W	Issue No.	20 (cont)
LM End	1.56	Issue Type +	Ma	Location *	
Category	Supplemental			GPS Latitude/Longitude	
				Start	End
Item	2017 Storm Damage			38.251886 °	38.252619 °
				-121.719933 °	-121.722842 °
DWR ID	DWR_RD2060_01_f_2017_20				
Comment Code					
Inspector Comment					
Levee Evaluation Comments					
Description:Erosion commences approximately halfway down the water side slope extending to the toe.					
Site ID No:365					
Site Designation:LMA-192					
Repair Type: Erosion					
Rating:Serious					
Field Date:7/12/2017					
Notes: Several deep narrow cuts into levee, but mostly minor erosion at highwater line.

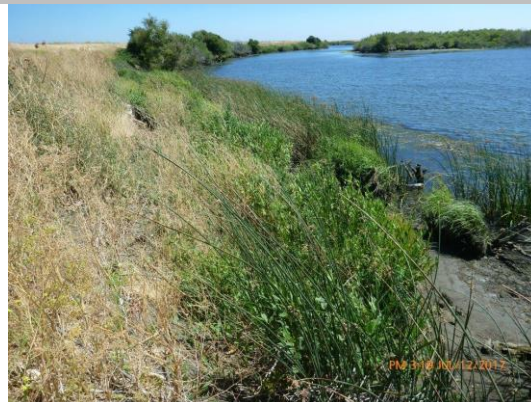
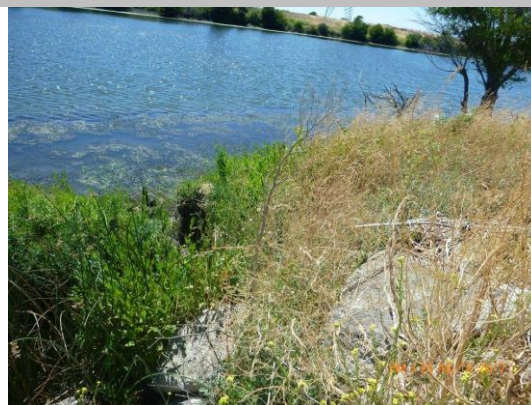
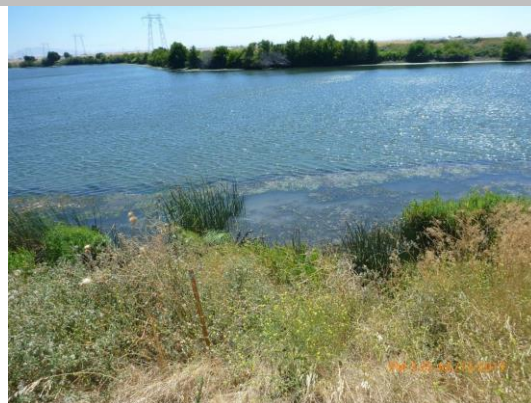
LM Start	1.81	Rating **	A/W	Issue No.	21
LM End	1.84	Issue Type +	Ma	Location *	
Category	Supplemental			GPS Latitude/Longitude	
				Start	End
Item	2017 Storm Damage			38.255972 °	38.256247 °
				-121.724197 °	-121.724464 °
DWR ID	DWR_RD2060_01_f_2017_21				
Comment Code					
Inspector Comment					
Levee Evaluation Comments					
Description:Erosion commences approximately halfway down the water side slope extending to the toe. Some slipping into the toe has occurred due to deep erosion.					
Site ID No:366					
Site Designation:LMA-193					
Repair Type: Erosion					
Rating:Serious					
Field Date:7/12/2017					
Notes: Erosion extends halfway into the slope.

LM Start	1.81	Rating **	A/W	Issue No.	21 (cont)
LM End	1.84	Issue Type +	Ma	Location *	
Category	Supplemental			GPS Latitude/Longitude	
				Start	End
Item	2017 Storm Damage			38.255972 °	38.256247 °
				-121.724197 °	-121.724464 °
DWR ID	DWR_RD2060_01_f_2017_21				
Comment Code					
Inspector Comment					
Levee Evaluation Comments					
Description:Erosion commences approximately halfway down the water side slope extending to the toe. Some slipping into the toe has occurred due to deep erosion.					
Site ID No:366					
Site Designation:LMA-193					
Repair Type: Erosion					
Rating:Serious					
Field Date:7/12/2017					
Notes: Erosion extends halfway into the slope.

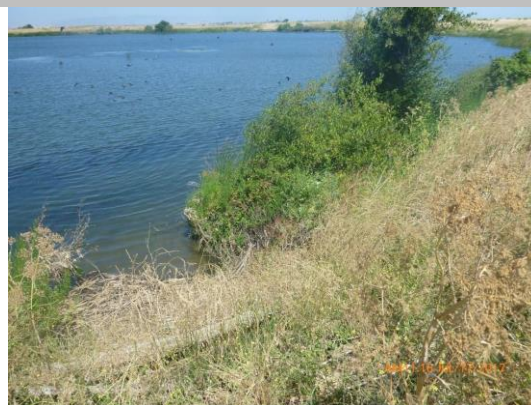
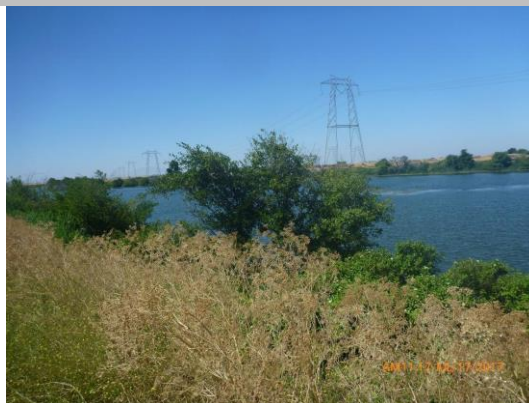
LM Start	1.90	Rating **	M	Issue No.	22
LM End	1.95	Issue Type +	Ma	Location *	
Category	Supplemental			GPS Latitude/Longitude	
				Start	End
Item	2017 Storm Damage			38.257208 °	38.257842 °
				-121.724619 °	-121.724694 °
DWR ID	DWR_RD2060_01_f_2017_22				
Comment Code					
Inspector Comment					
Levee Evaluation Comments					
Description:Erosion commences approximately halfway down the water side slope extending to the toe. Some slipping into the toe has occurred.					
Site ID No:367					
Site Designation:LMA-194					
Repair Type: Erosion					
Rating:Area of Concern					
Field Date:7/12/2017					
Notes: Minor crackingobserved below the hinge point and minor erosion at levee toe.

Notes: Minor cracking observed below the hinge point and minor erosion at levee toe.

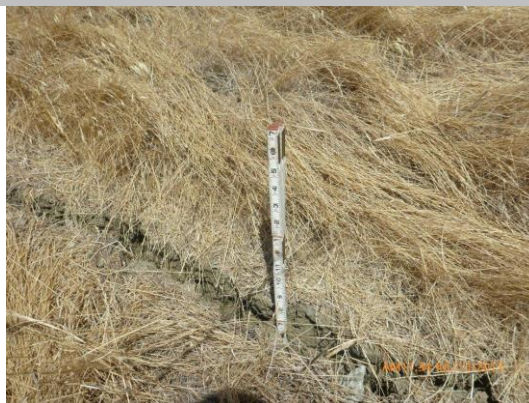
LM Start	3.07	Rating **	A/W	Issue No.	25
LM End	3.10	Issue Type +	Ma	Location *	
Category	Supplemental			GPS Latitude/Longitude	
				Start	End
Item	2017 Storm Damage			38.260772 °	38.260569 °
				-121.740817 °	-121.741194 °
DWR ID	DWR_RD2060_01_f_2017_25				
Comment Code					
Inspector Comment					
Levee Evaluation Comments					
Description:Erosion occurs near the waterline. Part of the levee has sloughed down toward the waterline due to erosion.					
Site ID No:370					
Site Designation:LMA-197					
Repair Type: Erosion					
Rating:Serious					
Field Date:7/13/2017					
Notes: Large erosion halfway into levee. Horizontal cracking on slope almost 24"deep.

LM Start	3.07	Rating **	A/W	Issue No.	25 (cont)	
LM End	3.10	Issue Type +	Ma	Location *		
Category	Supplemental			GPS Latitude/Longitude		
				Start	End	
Item	2017 Storm Damage			38.260772 °	38.260569 °	
				-121.740817 °	-121.741194 °	
DWR ID	DWR_RD2060_01_f_2017_25					
Comment Code						
Inspector Comment						
Levee Evaluation Comments						
Description:Erosion occurs near the waterline. Part of the levee has sloughed down toward the waterline due to erosion.						
Site ID No:370						
Site Designation:LMA-197						
Repair Type: Erosion						
Rating:Serious						
Field Date:7/13/2017						
Notes: Large erosion halfway into levee. Horizontal cracking on slope almost 24"deep.

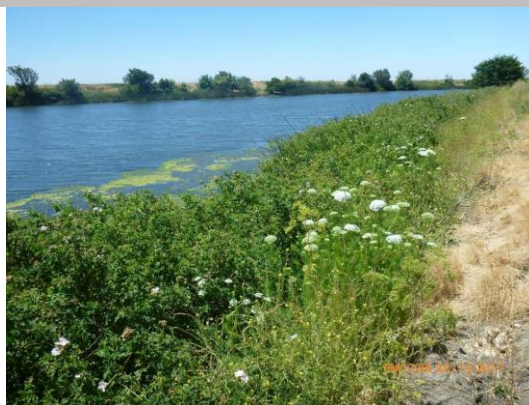
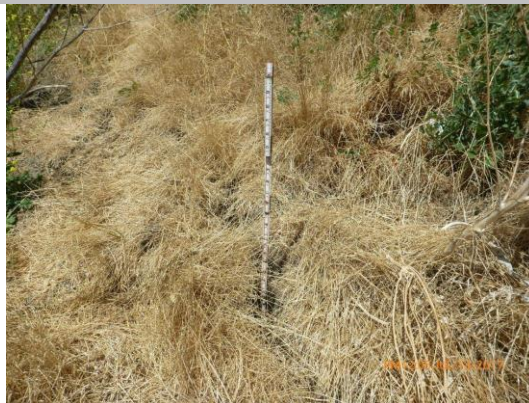
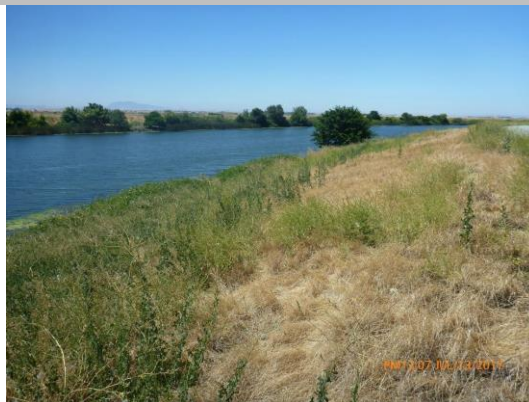
Photo 3 of 3 : SP_2018_RD2060_241_26_20180305_00046.jpg

LM Start	3.17	Rating **	M	Issue No.	26
LM End	3.17	Issue Type +	Ma	Location *	
Category	Supplemental			GPS Latitude/Longitude	
				Start	End
Item	2017 Storm Damage			38.259925 °	38.259903 °
				-121.742236 °	-121.742281 °
DWR ID	DWR_RD2060_01_f_2017_26				
Comment Code					
Inspector Comment					
Levee Evaluation Comments Description:Erosion occurs near the waterline. Site ID No:371 Site Designation:LMA-198 Repair Type: Erosion Rating:Area of Concern Field Date:7/13/2017 Notes: Minor erosion with sloughing. Horizontal cracks 3.5' deep.

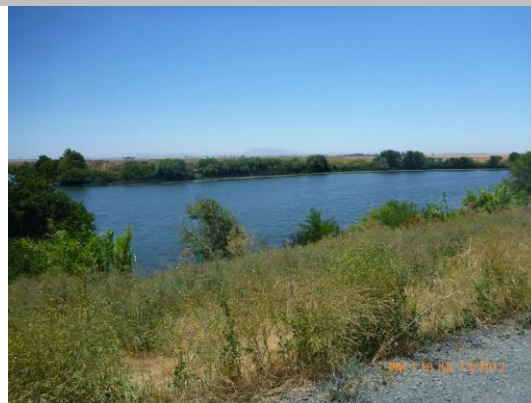
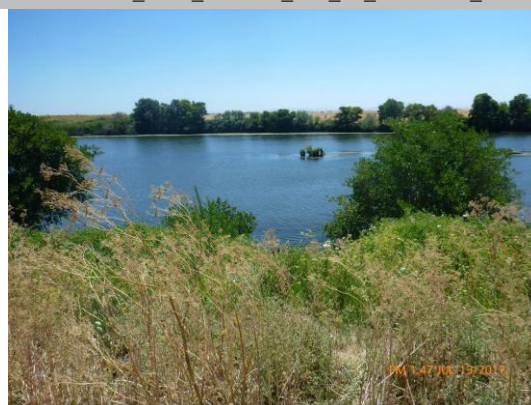
LM Start	3.67	Rating **	M	Issue No.	28
LM End	3.67	Issue Type +	Ma	Location *	
Category	Supplemental			GPS Latitude/Longitude	
				Start	End
Item	2017 Storm Damage			38.261181 °	38.261167 °
				-121.749542 °	-121.749592 °
DWR ID	DWR_RD2060_01_f_2017_28				
Comment Code					
Inspector Comment					
Levee Evaluation Comments					
Description:Erosion is concentrated near the water line.					
Site ID No:374					
Site Designation:LMA-201					
Repair Type: Erosion					
Rating:Area of Concern					
Field Date:7/13/2017					
Notes: Small narrow and deep cut. May have been caused by a collapsed beaver den.

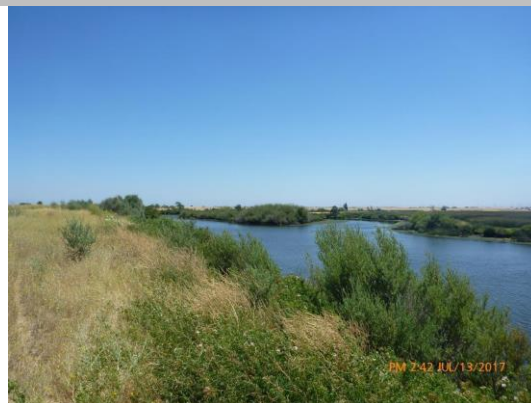
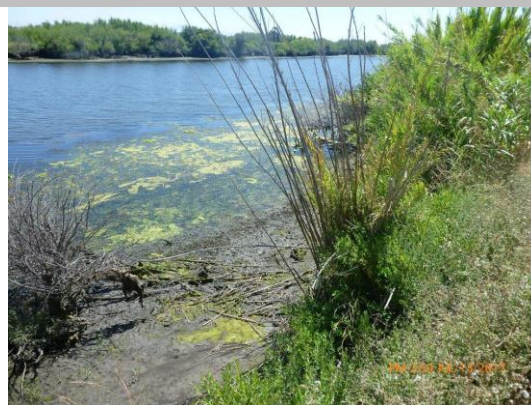
LM Start	4.40	Rating **	M	Issue No.	30
LM End	4.46	Issue Type +	Ma	Location *	
Category	Supplemental			GPS Latitude/Longitude	
				Start	End
Item	2017 Storm Damage			38.260850 °	38.260425 °
				-121.761875 °	-121.762861 °
DWR ID	DWR_RD2060_01_f_2017_30				
Comment Code					
Inspector Comment					
Levee Evaluation Comments					
Description:Erosion/sloughing commences approximately halfway down the slope. Erosion is concentrated mostly near the water line and has resulting in slippage of the slope.					
Site ID No:377					
Site Designation:LMA-204					
Repair Type: Erosion					
Rating:Area of Concern					
Field Date:7/13/2017					
Notes: large cut is 100' of 320' site. Large cut is 12' vertical and the rest is 6'.

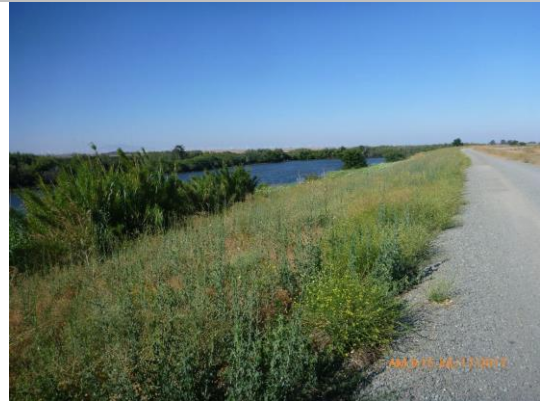
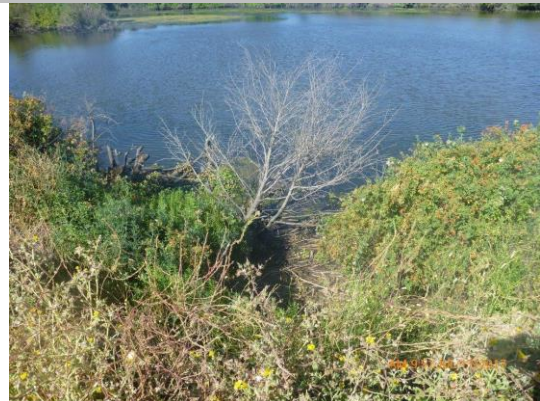
LM Start	4.80	Rating **	A/W	Issue No.	32
LM End	4.88	Issue Type +	Ma	Location *	
Category	Supplemental			GPS Latitude/Longitude	
				Start	End
Item	2017 Storm Damage			38.260714 °	38.261808 °
				-121.767972 °	-121.768536 °
DWR ID	DWR_RD2060_01_f_2017_32				
Comment Code					
Inspector Comment					
Levee Evaluation Comments					
Description: Erosion/sloughing commences approximately halfway down the slope. Erosion is concentrated mostly near the water line and has resulting in slippage of the slope towards the toe.					
Site ID No: 379					
Site Designation: LMA-206					
Repair Type: Erosion					
Rating: Serious					
Field Date: 7/17/2017					
Notes: Several erosions with slumping. Fresh soil indicates active erosion this season. Adjacent slope has riprap. Riprap should be extended along this stretch.

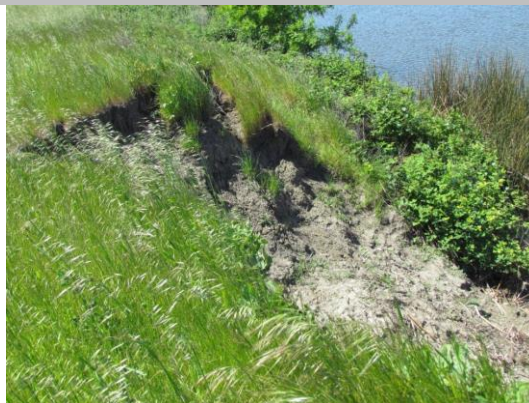
Looking upstream at the erosion on the waterside slope.
